**Commerce Commission**

**EXTREME EVENT STANDARD REPORTING – KAIKOHE ZONE SUBSTATION CIRCUIT BREAKER FAILURE, 6 NOVEMBER 2025**

The statement relates to the extreme event that occurred on 6 November 2025 at the Kaikohe 33 kV Zone Substation, being the catastrophic failure of Schneider Electric GHA-36-25-25 circuit breaker CB163612 (the T3 33 kV incomer, panel H05). The statement addresses each matter required by clauses 12.6(a) to 12.6(g), with the relevant clause reference identified against each section.

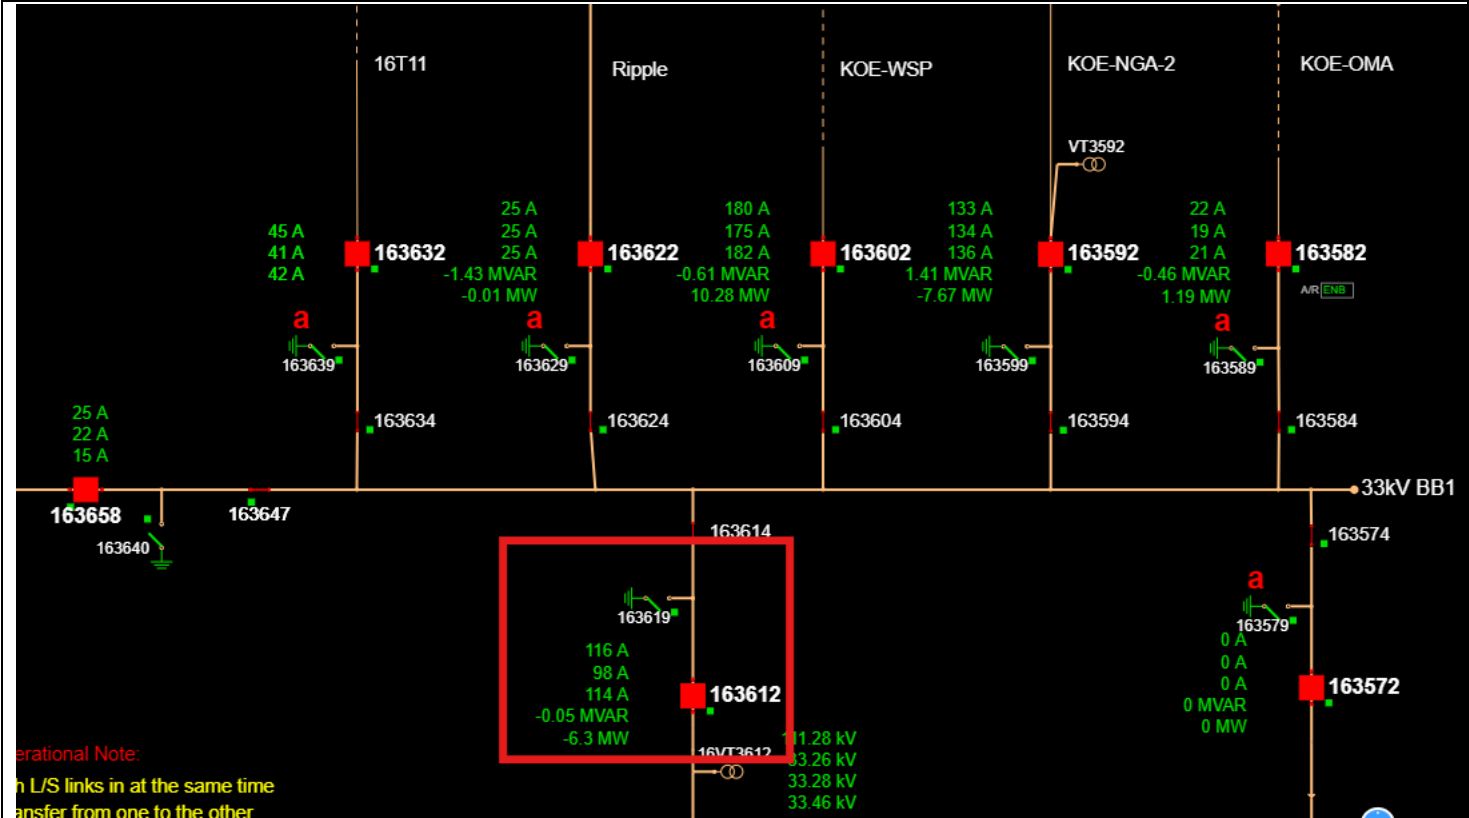
Fig 2: SLD from SCADA with H05 (CB163612) in the red block

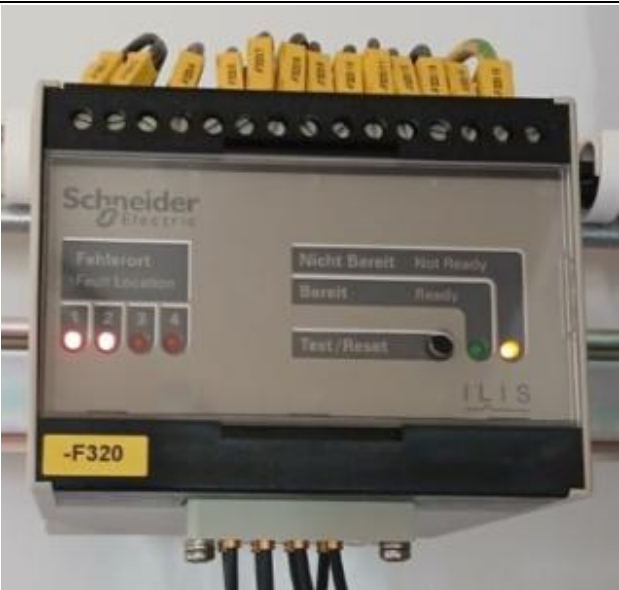
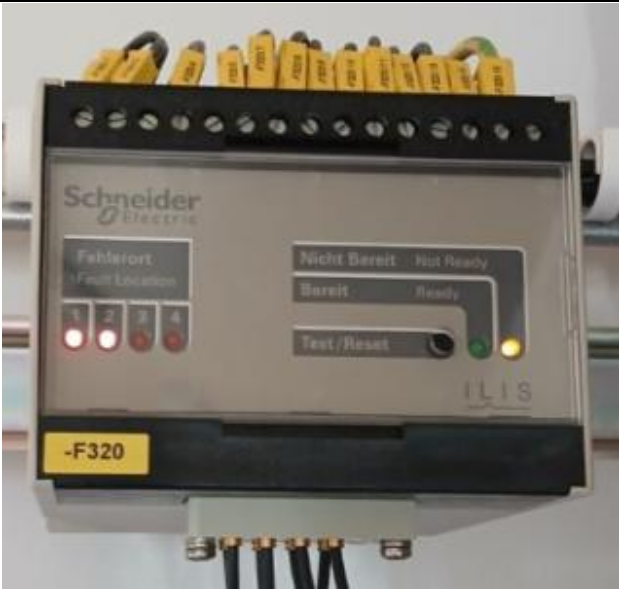
Fig 3: ILIS protection indication for T3 incomer breaker H05 (CB163612)

Fig 1: ILIS protection indication for T3 incomer breaker H05 (CB163612)

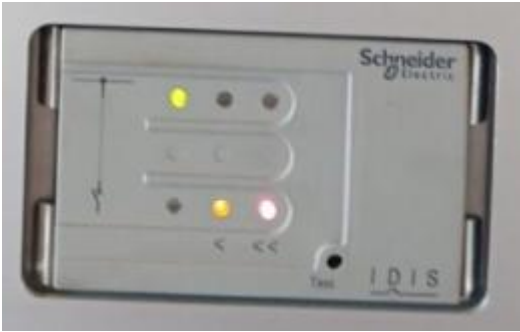
Fig 4: IDIS protection indication for T3 incomer breaker H05 (CB163612)

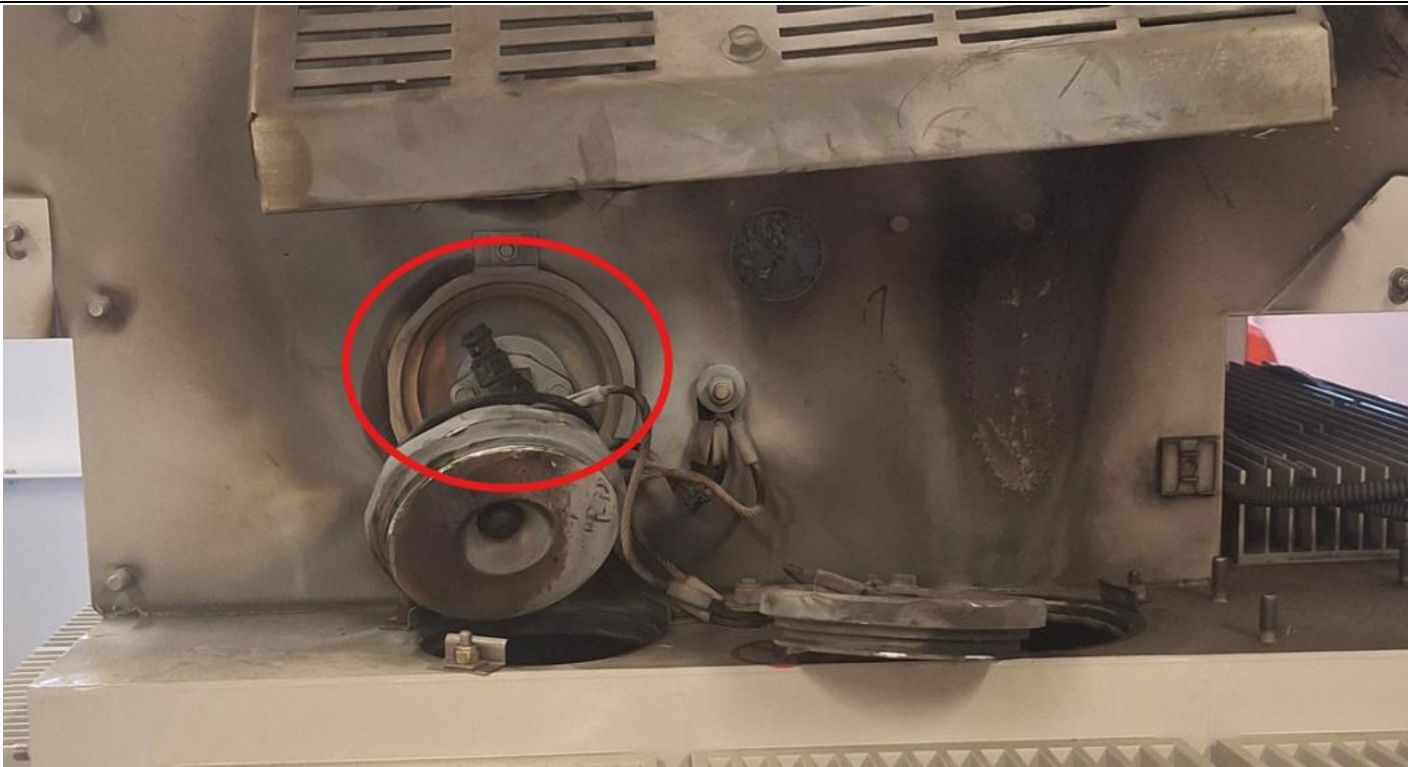
Fig 2: T3 incomer breaker H05 (CB163612 busbar chamber pressure flap intact but ILIS busbar chamber arc sensor damaged)

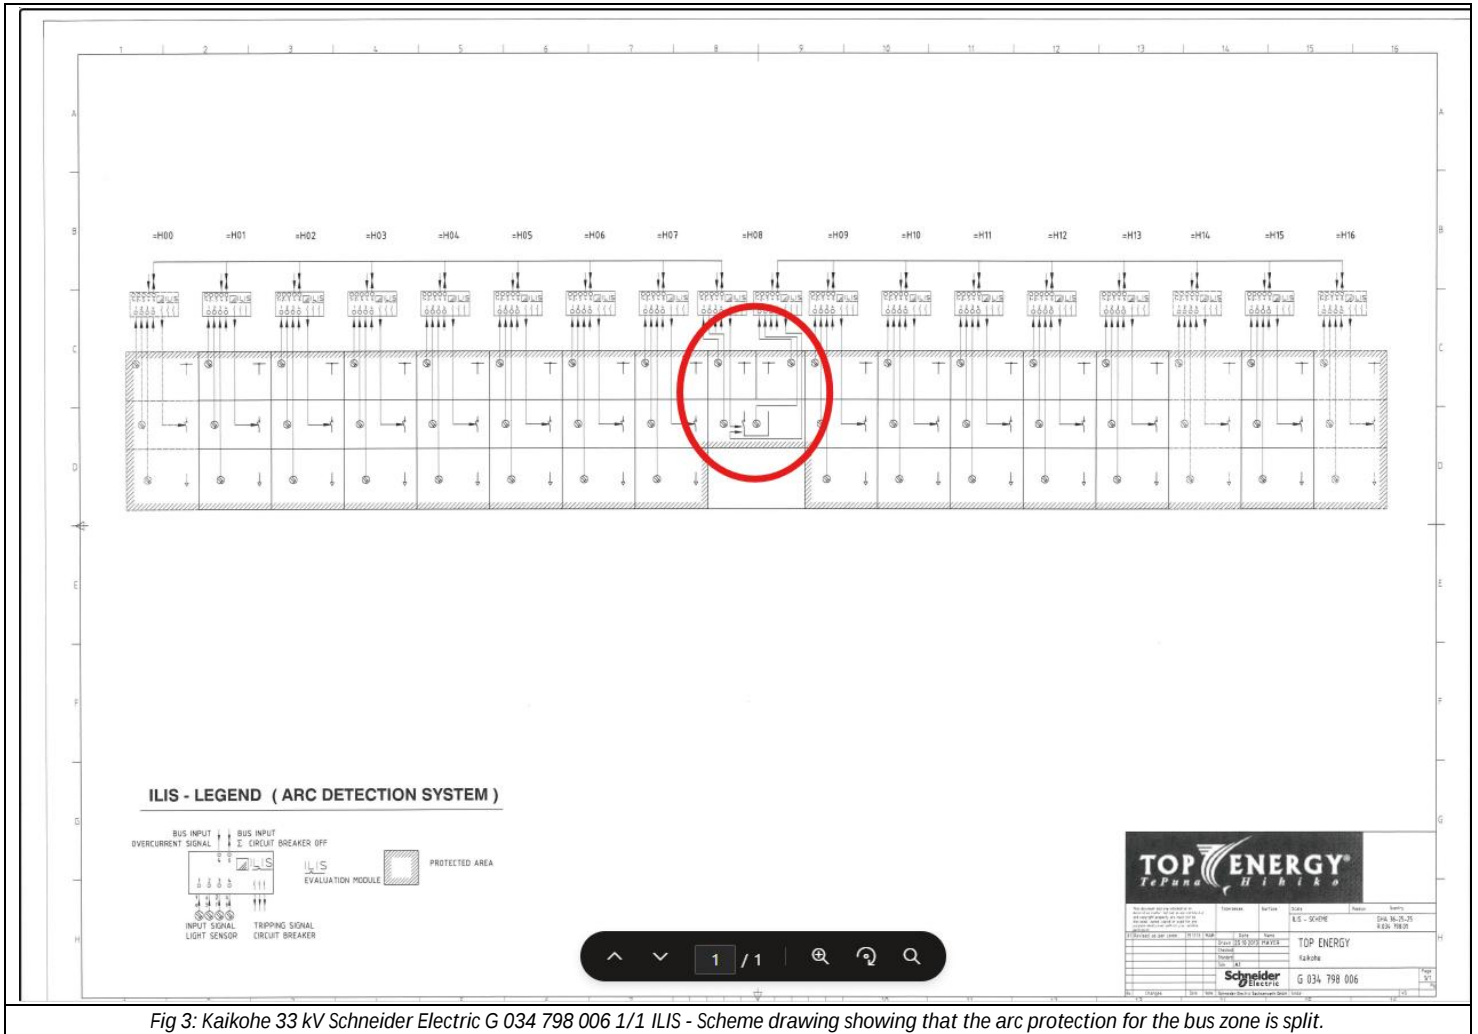
Fig 3: Kaikohe 33 kV Schneider Electric G 034 798 006 1/1 ILIS - Scheme drawing showing that the arc protection for the bus zone is split.

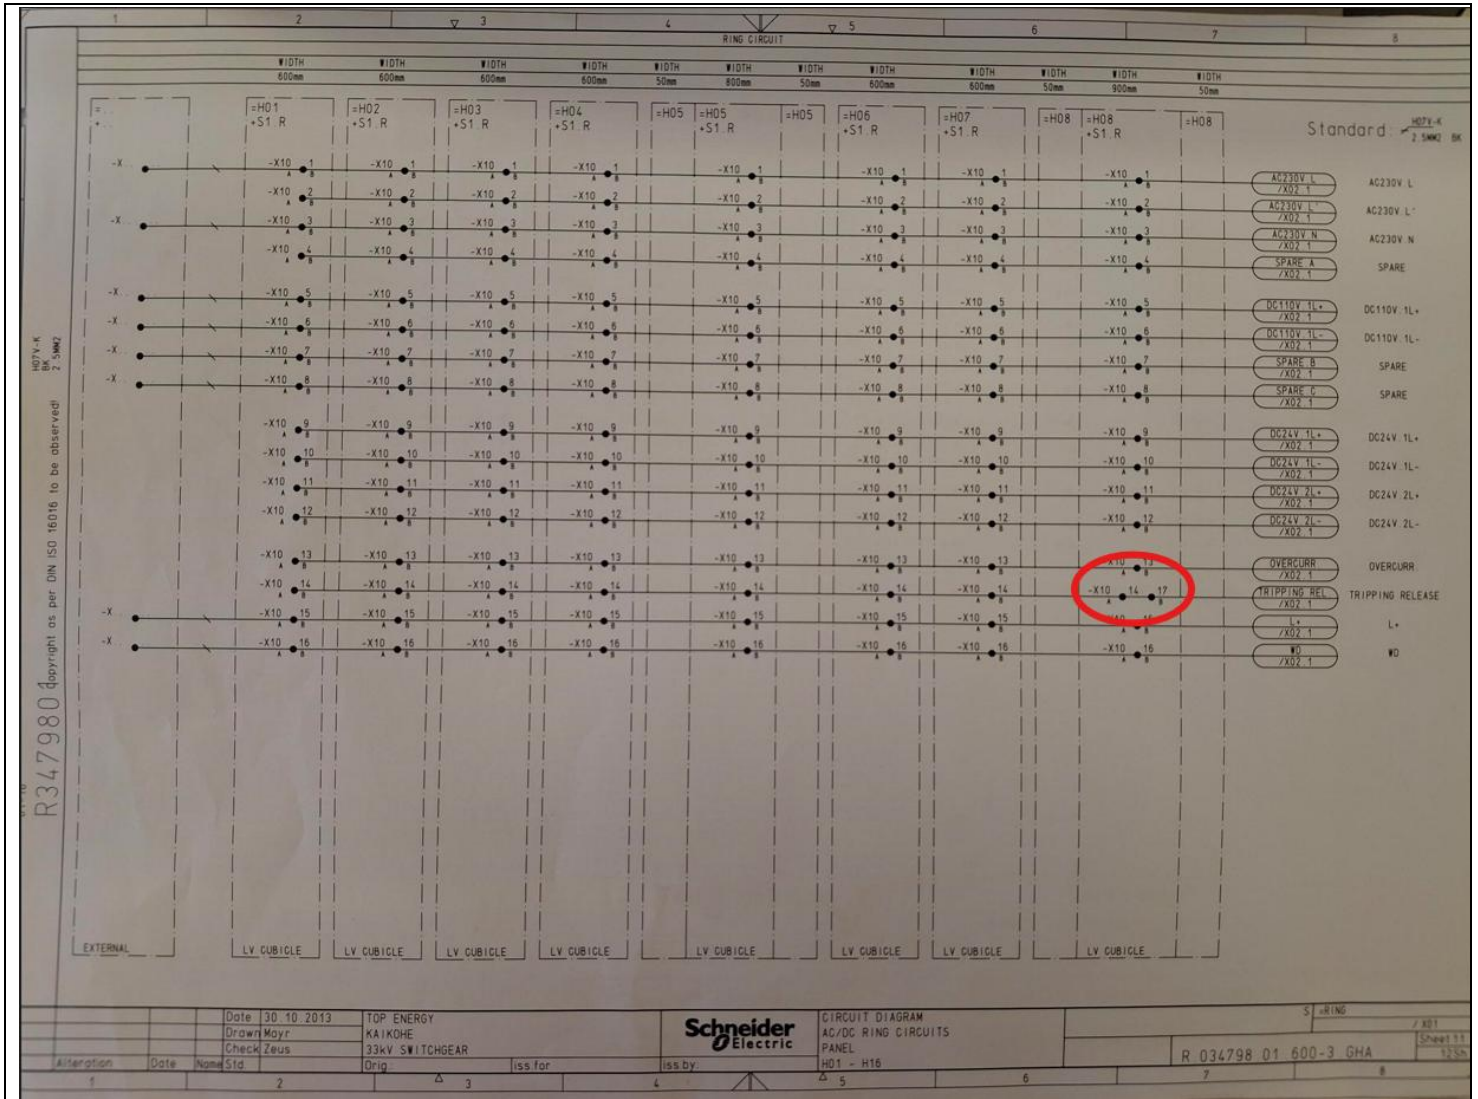
- The cause was arc-flash protection wiring (ILIS) with the Bus A and Bus B trips connected together in the bus coupler panel — the manufacturer's default configuration — so a fault on either bus tripped both. This is contrary to Top Energy's protection design standard (trip A or B depending on fault location), introduced in 2010.

Fig 4: Schneider Electric Dwg R034798.01.600-3 GHA Sheet 11 showing a connection between the A and B bus

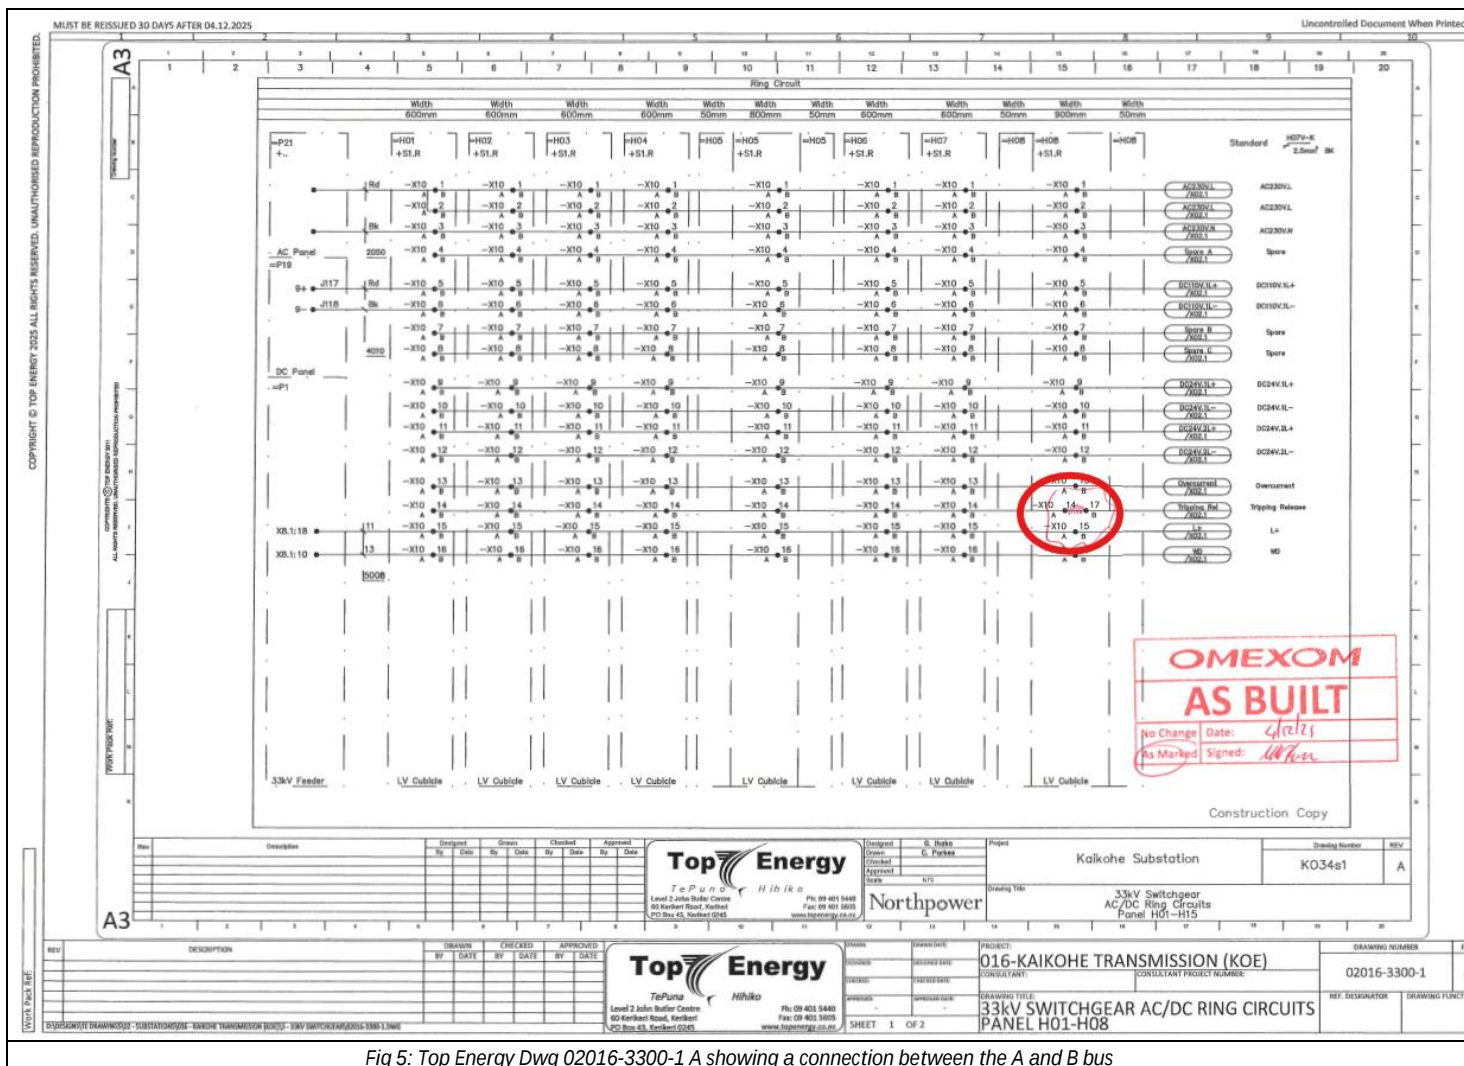
Fig 5: Top Energy Dwg 02016-3300-1 A showing a connection between the A and B bus

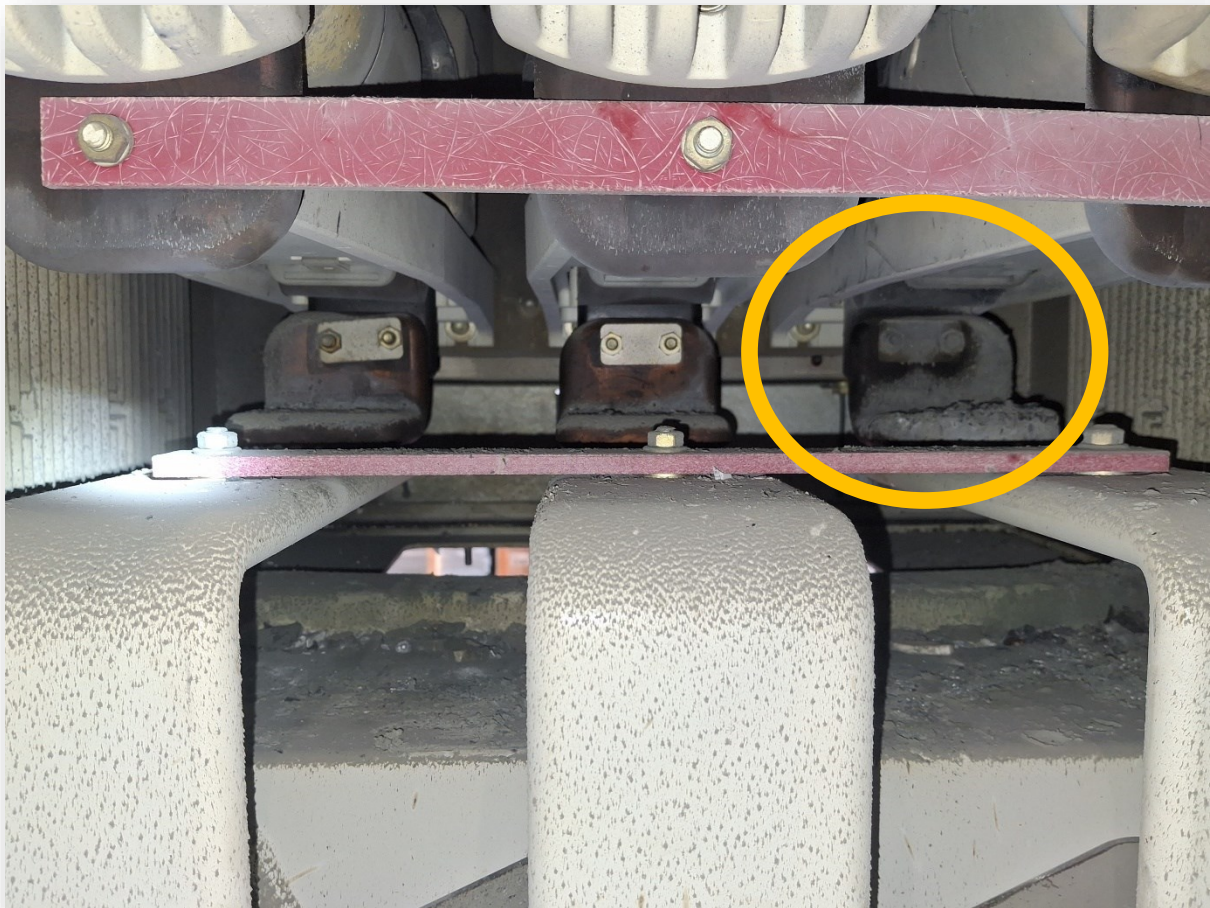
- Inspection revealed multiple arcing sites, especially at or above the three vacuum interrupter bottles, which are central to the breaker's function. Below these interrupters, minimal arcing damage was observed. Notably, the L1 phase showed significant burning and arcing below the moving contact drive link, unlike the cleaner L2 and L3 phases.

**Figure 1:** The vacuum interrupter assemblies are at the top of the image. Just below them are bolted connections that connect to the copper connectors that leave the chamber below the bottom of the image. The difference between the right hand L1 phase and the other two connections bolted connections is highlighted.

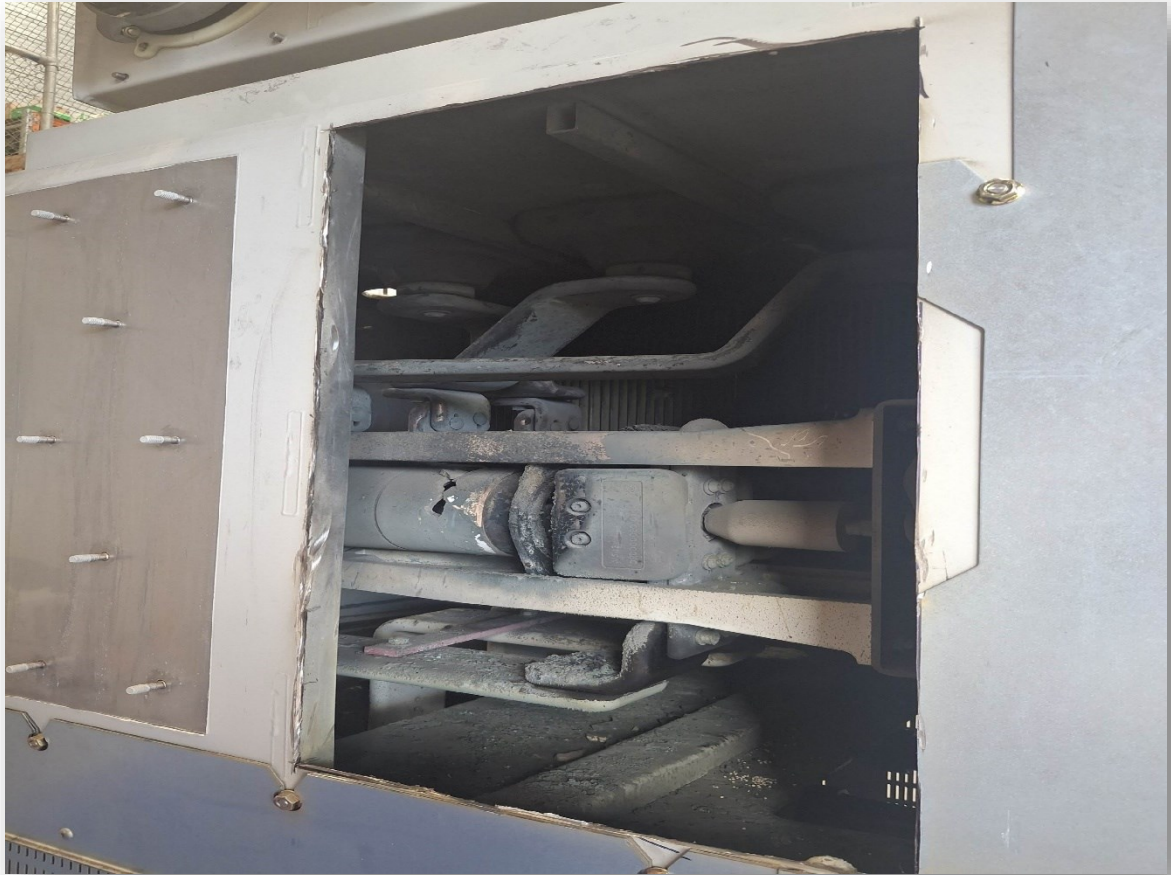
**Figure 2:** Opening created adjacent to the L1 circuit breaker assembly. Holes in the L1 vacuum interrupter are noted in the middle of the image.

- The ceramic housing of the interrupters on both L1 and L2 phases were found to have ruptured.
- Severe arcing damage was found on the L1 circuit's current path between the interrupter and its drive mechanism, specifically at the interface of the interrupter stem and a large copper plate. Over 20 millimetres of copper eroded, creating an air gap, although the interrupter stem appeared externally intact.
- Schneider technicians were unfamiliar with the joint's construction.
- The molten copper debris discovered beneath the L1 interrupter resulted from prolonged overheating and dripping metal.

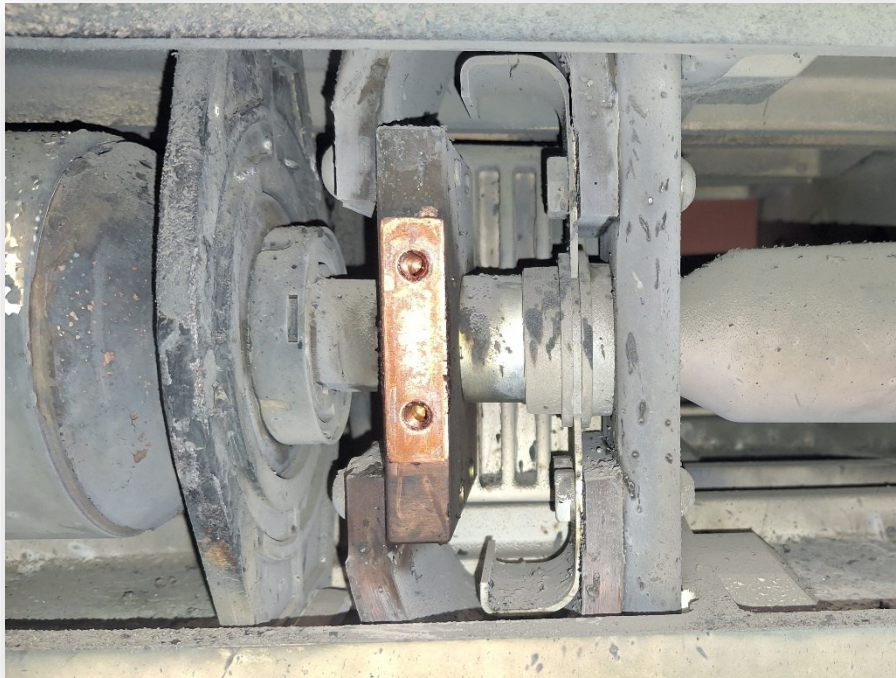
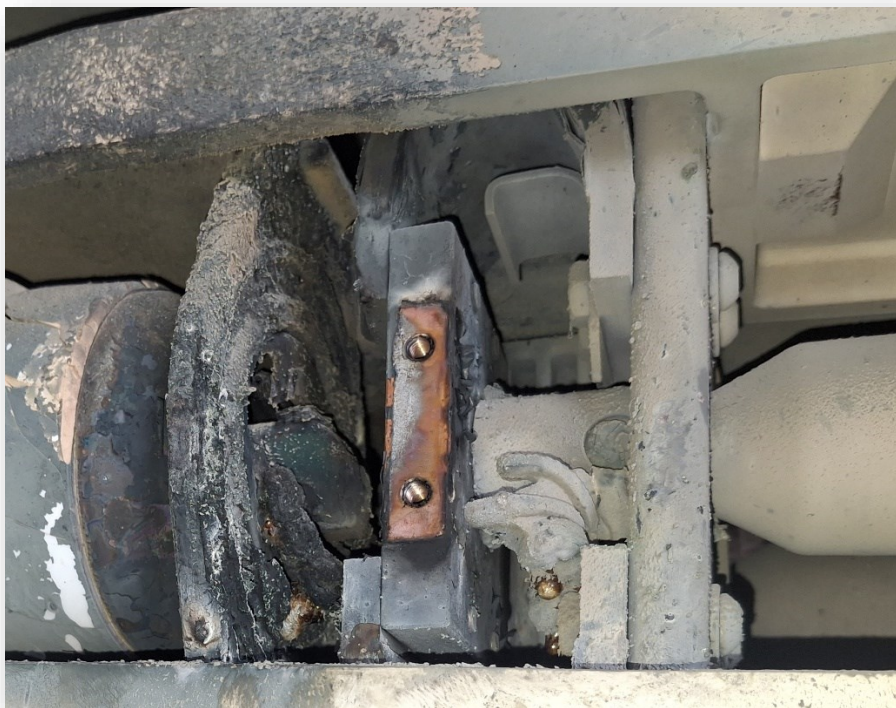
**Figure 3:** This pair of images shows the L3 phase moving assembly above and the L1 phase moving assembly below note the L3 phase image has been mirrored to provide an equivalent image. Note the severe damage on the L1 phase moving assembly.

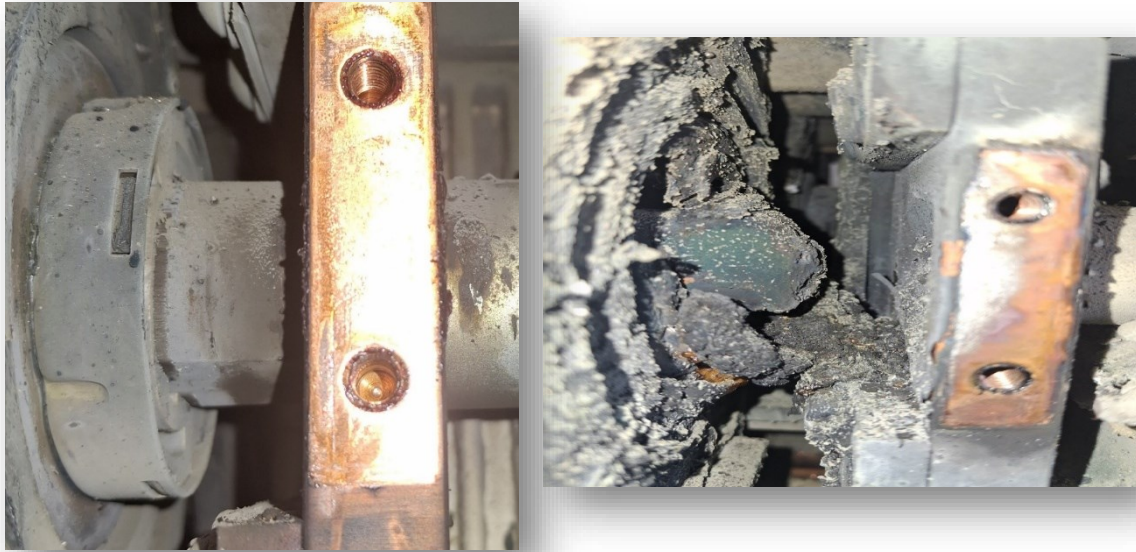
**Figure 4:** the L1 moving assembly above shows the end of the vacuum interrupter, the stem of the moving contact that is connected to the large copper plate in good condition. The L1 part of the image below shows approximately 20 millimetres of that shaft has been eroded by arcing.

- This contact is deep within the mechanism of the circuit breaker and not user serviceable or user accessible. Further, it is not serviceable by Schneider technicians in New Zealand.
- It was assembled by Schneider in the factory and has been enclosed in an SF6 filled gas chamber so entirely non-accessible since.
- It is recognised that the failed connection is both current carrying in its function and also provides mechanical drive for the interrupter. At this point in time the construction of this connection is not understood nor is its failure mode.
- **We await Schneider's perspective on the failure and their description of how this connection may have deteriorated over the time in service of this circuit breaker chamber.**
