**Commerce Commission**

**EXTREME EVENT STANDARD REPORTING – KAIKOHE ZONE SUBSTATION CIRCUIT BREAKER FAILURE, 6 NOVEMBER 2025**

The statement relates to the extreme event that occurred on 6 November 2025 at the Kaikohe 33 kV Zone Substation, being the catastrophic failure of Schneider Electric GHA-36-25-25 circuit breaker CB163612 (the T3 33 kV incomer, panel H05). The statement addresses each matter required by clauses 12.6(a) to 12.6(g), with the relevant clause reference identified against each section.

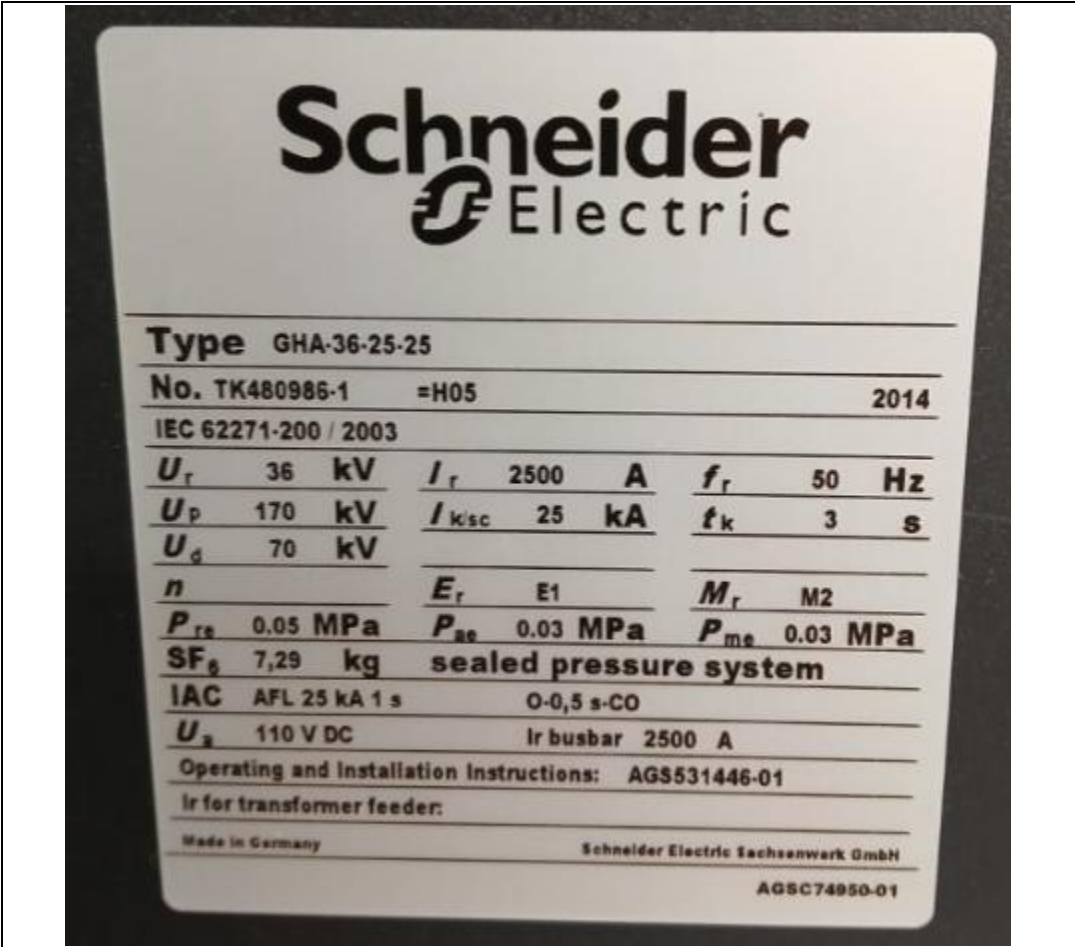
Fig 1: Nameplate for T3 incomer breaker H05 (CB163612)

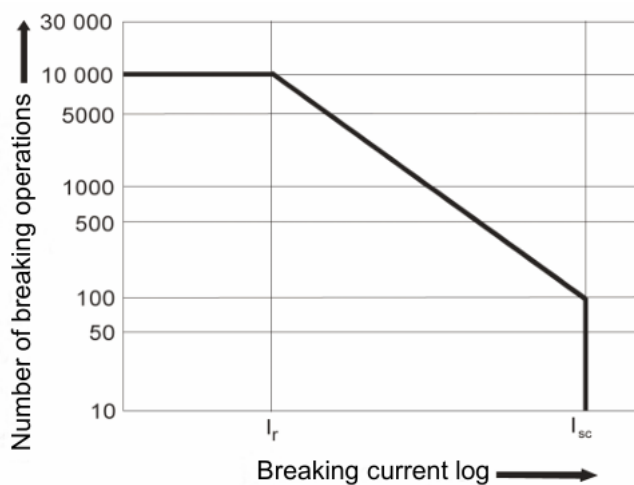
**Figure 112 –Admissible Numbers for Breaking Operations for the Vacuum Interrupter Chamber**

TE records show that CBI63612 has operated for a total of 68 times since commissioned in 2014 and none of the operations was for clearing fault currents. This history confirms that the circuit breaker is still well within the manufacturer's specifications for admissible summation current limit as indicated in Figure 112 of their *Installation, Operation, and Maintenance Instructions Bulletin* and copied below for reference.

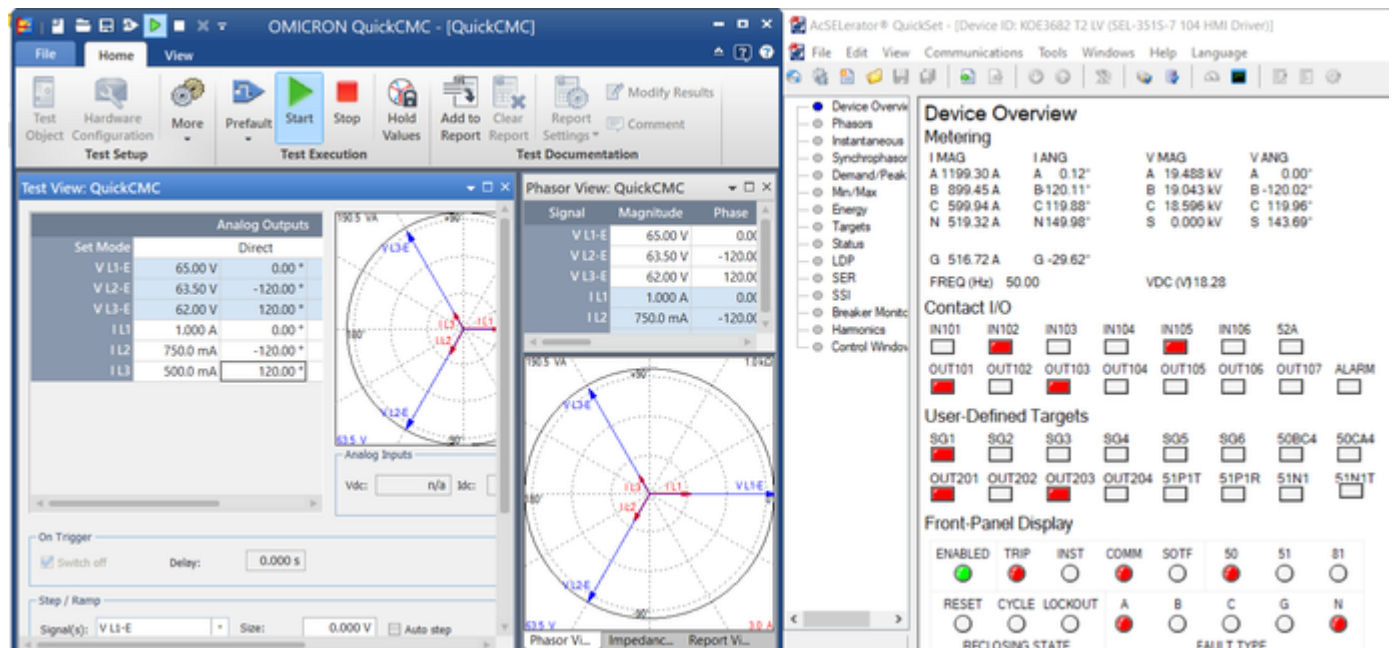
CB163612 Screen Capture.PNG

No Relay alarms or CB alarms seen at control
